L1110900003 - McHenry Co. Techalloy ILD000646828 S.F./HRS

Resource Applications, Inc. (RAI), performed a preliminary assessment and visual site inspection (PA/VSI) to identify and assess the existence and likelihood of releases from solid waste management units (SWMU) and other areas of concern (AOC) at the Techalloy Illinois, Inc. (Techalloy) facility in Union, Illinois. This report summarizes the results of the PA/VSI and evaluates the potential for releases of hazardous wastes or hazardous constituents from SWMUs and AOCs identified. In addition, a completed U.S. Environmental Protection Agency (EPA) Preliminary Assessment Form (EPA Form 2070-12) is included in Attachment A to assist in prioritization of RCRA facilities.

RAI conducted a VSI at the Techalloy facility at 9:15 AM on April 3, 1991. George Miller explained the facility's operating procedures and waste management practices. During the inspection, RAI did not observe any problems with mismanaged wastes. RAI concluded the

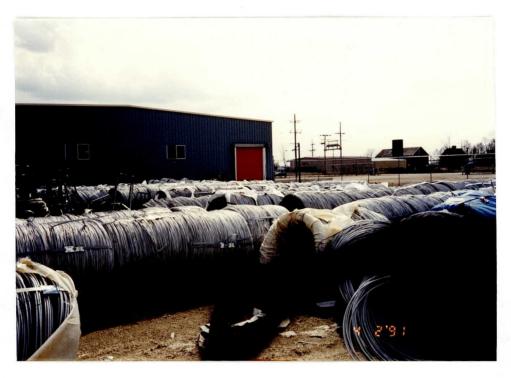
Photograph No.: 1 Title: Wire Storage Area
Orientation: Southeast Date: April 3, 1991
Description: View of unprocessed wire and shipping dock.

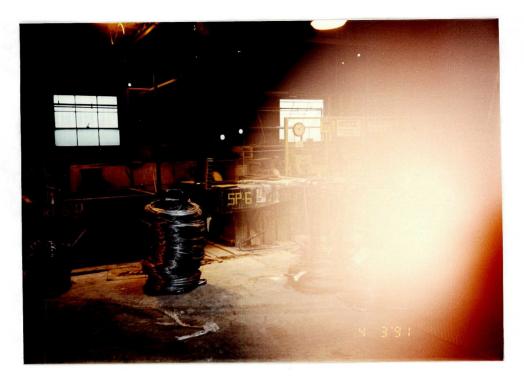
Photograph No.: 3 Title: Wire Lubricant Tanks

Description: One 1,350 gallon WKLS tank and One 2,400 gallon SP-6 tank are contained in a

5,000 gallon concrete enclosure. The tanks are used as a wire lubricant.

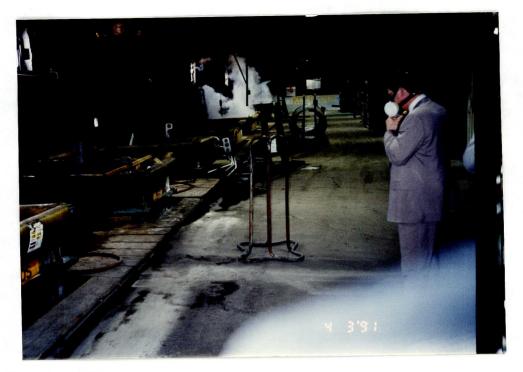
Photograph No.: 5

Title: Acid House Room (Pickling house)

Description: This series of tanks are used to remove the scale build up on the wire.

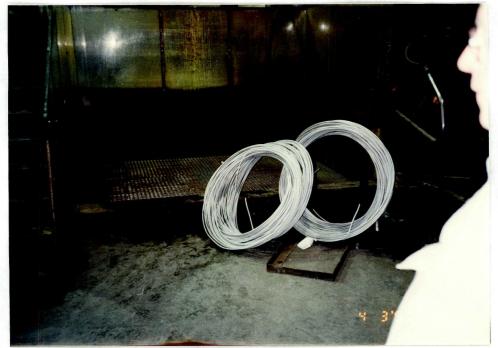
Photograph No.: 7 Title: Nickel Plating Area Orientation: West Date: April 3, 1991

Description: The wire is dipped in bath of nickel sulfate and rinsed with water. This is a closed

loop system and no waste is generated.

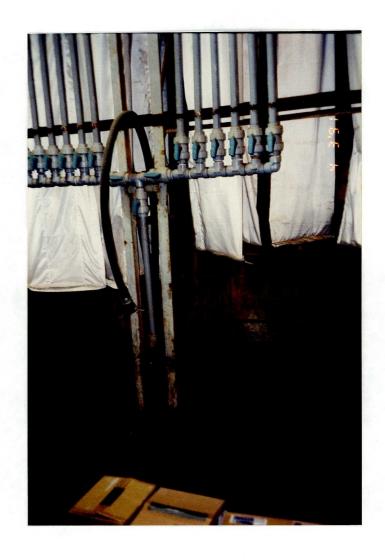
Photograph No.: 9

Title: Hazardous Waste Water Unit

Description: The gravity filtration bags are used to settle sludge from spent acids. This unit is

undergoing RCRA Closure.

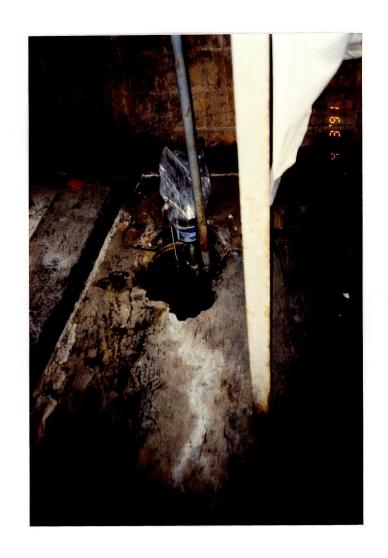
Photograph No.: 11 Orientation: Northwest Title: Sump Pump Date: April 3, 1991

Description: Sump Pump on floor below the gravity filtration bags. Concrete berm containing

this portion of the unit is six inches high. This unit is undergoing RCRA Closure.

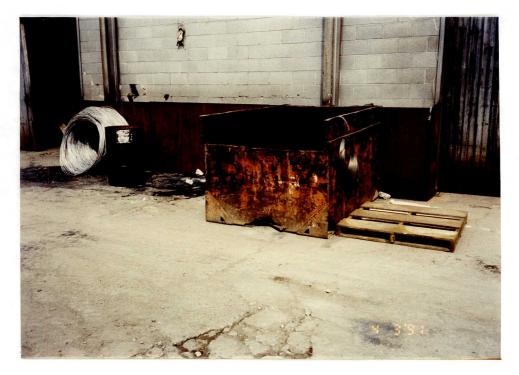
Photograph No.: 12 Title: Wire Slag Container Orientation: North Date: April 3, 1991

Description: This unit stores oxidized wire. Scrap haulers remove the waste from the facility.

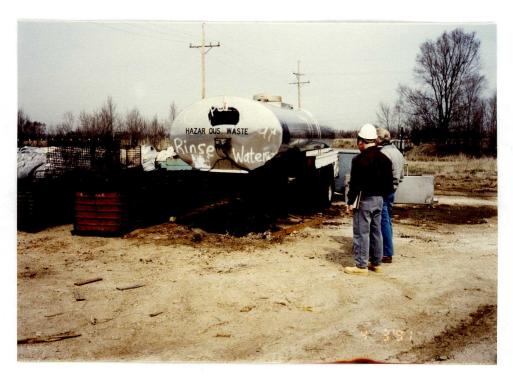
Photograph No.: 13 Title: Cyanide Destruction Unit

Description: This unit was used to remove the cyanide from the copper cyanide plating waste. This

unit is undergoing RCRA closure.

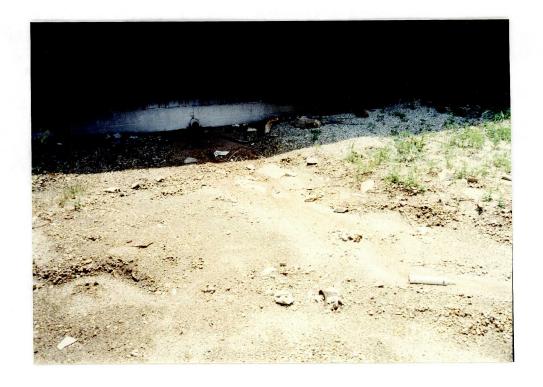
Photograph No.: 14 Title: Plating Waste Disposal Area

Description: This area was used to dispose of spent plating waste from 1968 to 1979. View is

facing pickling house.

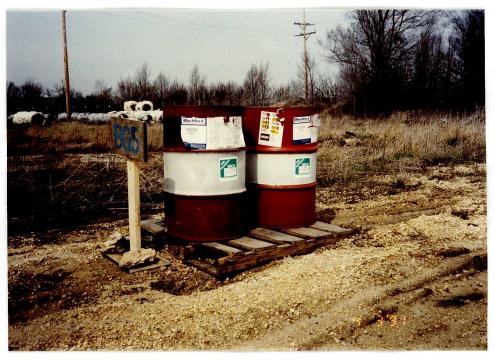
Photograph No.: 15 Title: BG-5 Oil Drums Orientation: Northwest Date: April 3, 1991

Description: North of pickling house, these drums are used to store waste BG-5 oil.

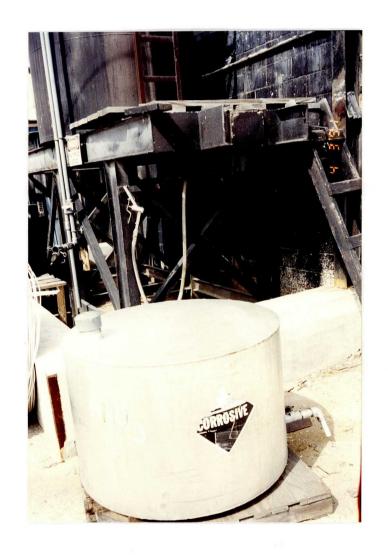
Photograph No.: 17 Title: Transfer Tank Orientation: Southeast Date: April 3, 1991

Description: This unit is used to transfer nitric acid from the storage tank to the pickling house.

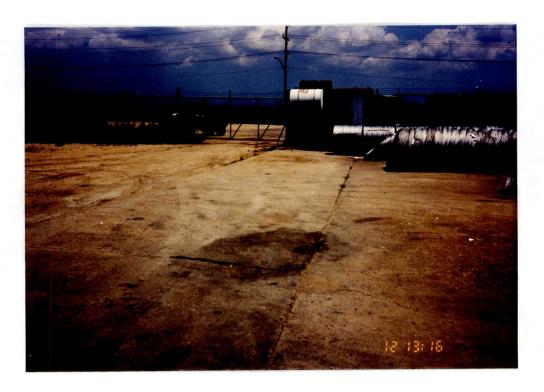
Photograph No.: 18

Title: Concrete Evaporation Pad

Description: This area was used to dispose of spent solvents from 1968 to 1979. Note: Concrete

slab is level and contains cracks.

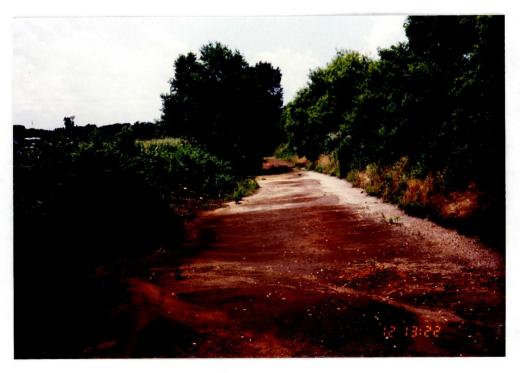
Photograph No.: 19

Title: Spent Acid Holding Pond
